Merlin Musings

Ted Devey

Overhauling a Merlin 622 (2)

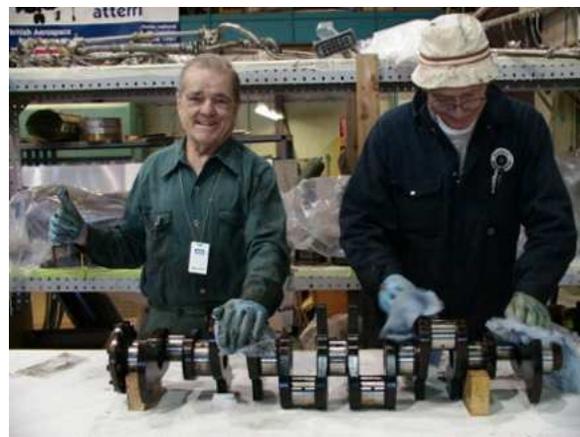
Figure 1: Ted Devey (L) , Peter Houston and crankshaft. Oil holes are visible on the crank journals that feed through the connecting rods to the wrist pins on the pistons

the inside of the engine. The sump is drained by scavenge pumps and the oil is returned to the oil tank on the firewall via the oil-cooling radiator at the front of the nacelle. The crankshaft forms an important part of the lubrication system. The condition of the main and crank journals was very good and measurements indicated very little wear.

On completing overhaul and cleaning of the crankshaft, it was remounted on the Crankcase Upper Half, the cap bolts were torqued, and the horizontal bolts which go from one side of the crankcase to the opposite side through the bearing caps were replaced and tightened. Every piece of the engine was cleaned before they were returned for assembly: nuts, bolts, studs, washers etc. The crankshaft was then ready to receive the pistons and connecting rods.

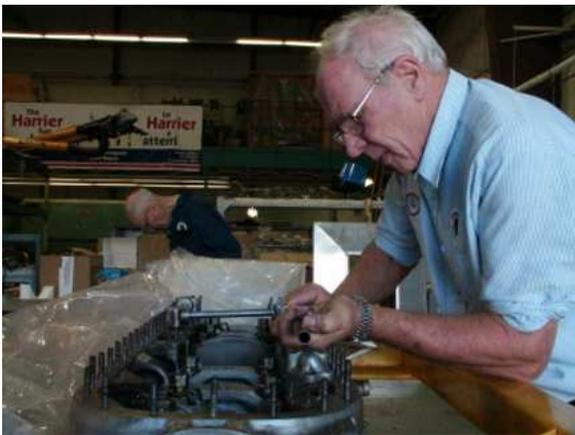
Figure 2: Don Craig working on the oil distribution piping inside the crankcase, rotary stand in the inverted position

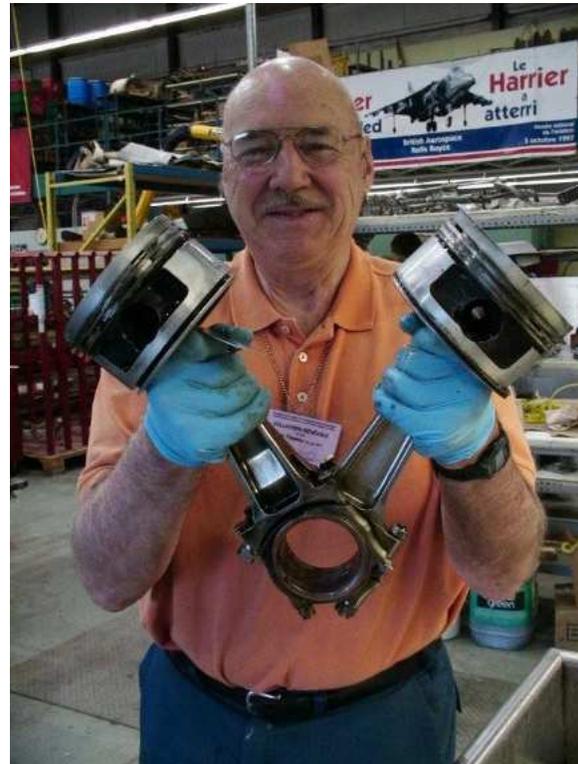
Figure 3: Tim Timmins holding a piston-connecting rod pair that shows the fork-and-blade configuration

Because of corrosion between some piston rings and cylinder sleeve walls, a number of rings broke on dismantling and were replaced with new rings. The pistons were cleaned with great care and the use of harsh abrasives was avoided. This was very time consuming. Pistons were marked with the letter 'T' which indicated orientation toward the intake valves. Corrosion was most pronounced in cylinders which had exhaust valves open to the atmosphere. In Port Bank cylinders two and five, an oil-soaked bumble bee carcass was found on top of each piston!

When the overhaul of the six piston-connecting rod assemblies was completed, they were remounted to the crankshaft awaiting later return of the two cylinder banks to the engine assembly.

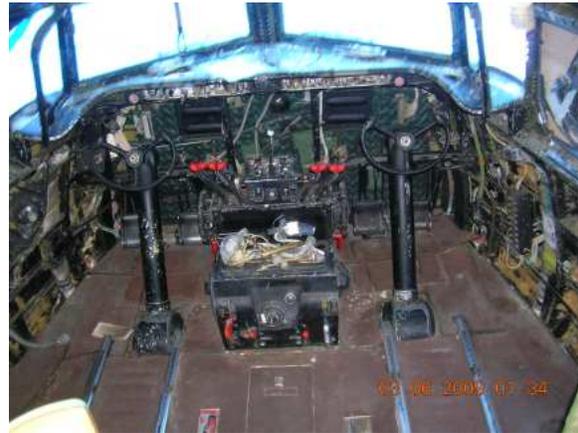
several small areas of corrosion that needed to be repaired before further work could be done.

Figure 1: The North Star cockpit stripped of most equipment and fittings, in preparation for repainting

Over in the restoration shop, several volunteers cut and shaped new pieces of aluminum, following detailed patterns and measurements taken from the corroded areas. Severely corroded metal was cut out and new pieces riveted into place. Lesser damage was often treated by grinding down the corroded surface and treating the area with Alumiprep to stop further corrosion.
