# The NStar Chronicle

## North Star Restoration Report

Our team of volunteers continues to make steady progress on our North Star restoration. We have had several additional volunteers join our group. This has allowed us to expand our scope of work to include some preparation work on the fuselage in addition to ongoing work on engine Nr 2 and in the cockpit area.

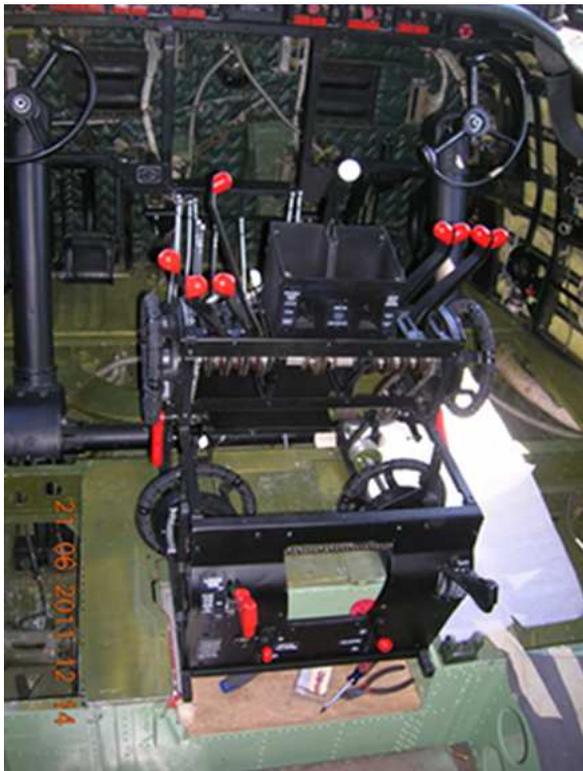
Control pedestal

Since our last report, most of the equipment and many cables have been removed from the large navigation equipment rack behind the cockpit. This large equipment rack needs a thorough cleaning and other preparatory work prior to painting this summer. The small galley was removed in order to improve access to this rack. During removal we discovered a secondary hydraulic fluid reservoir—still full—that was not well documented. We drained the fluid and removed this tank as well. Over the winter a lot of work was done repairing the headliner panels removed from the cockpit. Luckily, the panels from behind the radio rack were in good condition, with only minor tears. After repairs were made these panels were painted to match the original colour, and were installed behind the radio rack before the rest of the equipment was re-installed. The rudder pedals and control column have been installed, and new padded bumpers were fastened to the leading edge

The rudder pedals were restored and have been installed, and we are now working on the installation of the central control console and the many cables that connect to these controls. We also replaced the leather bumpers along the edge of the sunshield, and we have test fitted the new cockpit curtains. We recently received a cable swaging tool that allows us to fabricate new cables on site. We are sharing the cost of this tool with the Aviation Museum, which is a major investment for us.

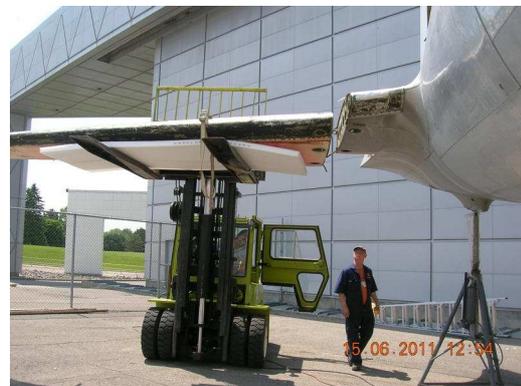
Horizontal stabilizer removal

This is a new section of the report. Little has been done on the fuselage itself, due to lack of manpower and other priorities. Recently, the bolts holding the horizontal stabilizers and the flaps were removed and greased to ensure these can be quickly and easily removed when it is time to take off the horizontal stabilizers and flaps for overhaul. These items are very large and the museum does not have the facilities to handle such large assemblies, so they will be shipped to another location for overhaul. Likewise, the brake packs were removed from the main landing gear so the brakes can be overhauled. Work has now started on restoration of the forward baggage compartment. This will be followed by cleaning and restoration of the belly equipment hold and the engine nacelles. Each of these areas must be stripped of cables, conduits, access panels and various pumps and accessories before they can be painted and re-assembled. As an added challenge, these areas are small with limited access, so working in these areas will be difficult. We have also managed to get a large portion of the forward fuselage polished. This will be an ongoing project, but the effort put into polishing the external aluminum skin will be very visible and will show the progress we are making on the aircraft.

We are still planning to remove major pieces of the aircraft, such as the horizontal stabilizers and the flaps, so they can be sent out for overhaul. We do not have the equipment to work on such large items. In preparation, each securing bolt was removed from each stabilizer, greased and replaced. This will make the eventual removal go quickly. The same preparation was done for each of the flaps. The four large brake packs have also been removed from the main landing gear. These will also go for overhaul to a specialized facility. Work has now begun cleaning the forward baggage compartment, in preparation for painting. There are several belly compartments, as well as the four nacelles behind the engines that all need cleaning and restoration work. The forward part of the fuselage was also polished during the winter.
